SPECIAL PUBLICATION 116

THE NORTHRIDGE, CALIFORNIA, EARTHQUAKE OF 17 JANUARY 1994

DIVISION OF
MINES AND GEOLOGY

**The Northridge, California, Earthquake
of 17 January 1994**

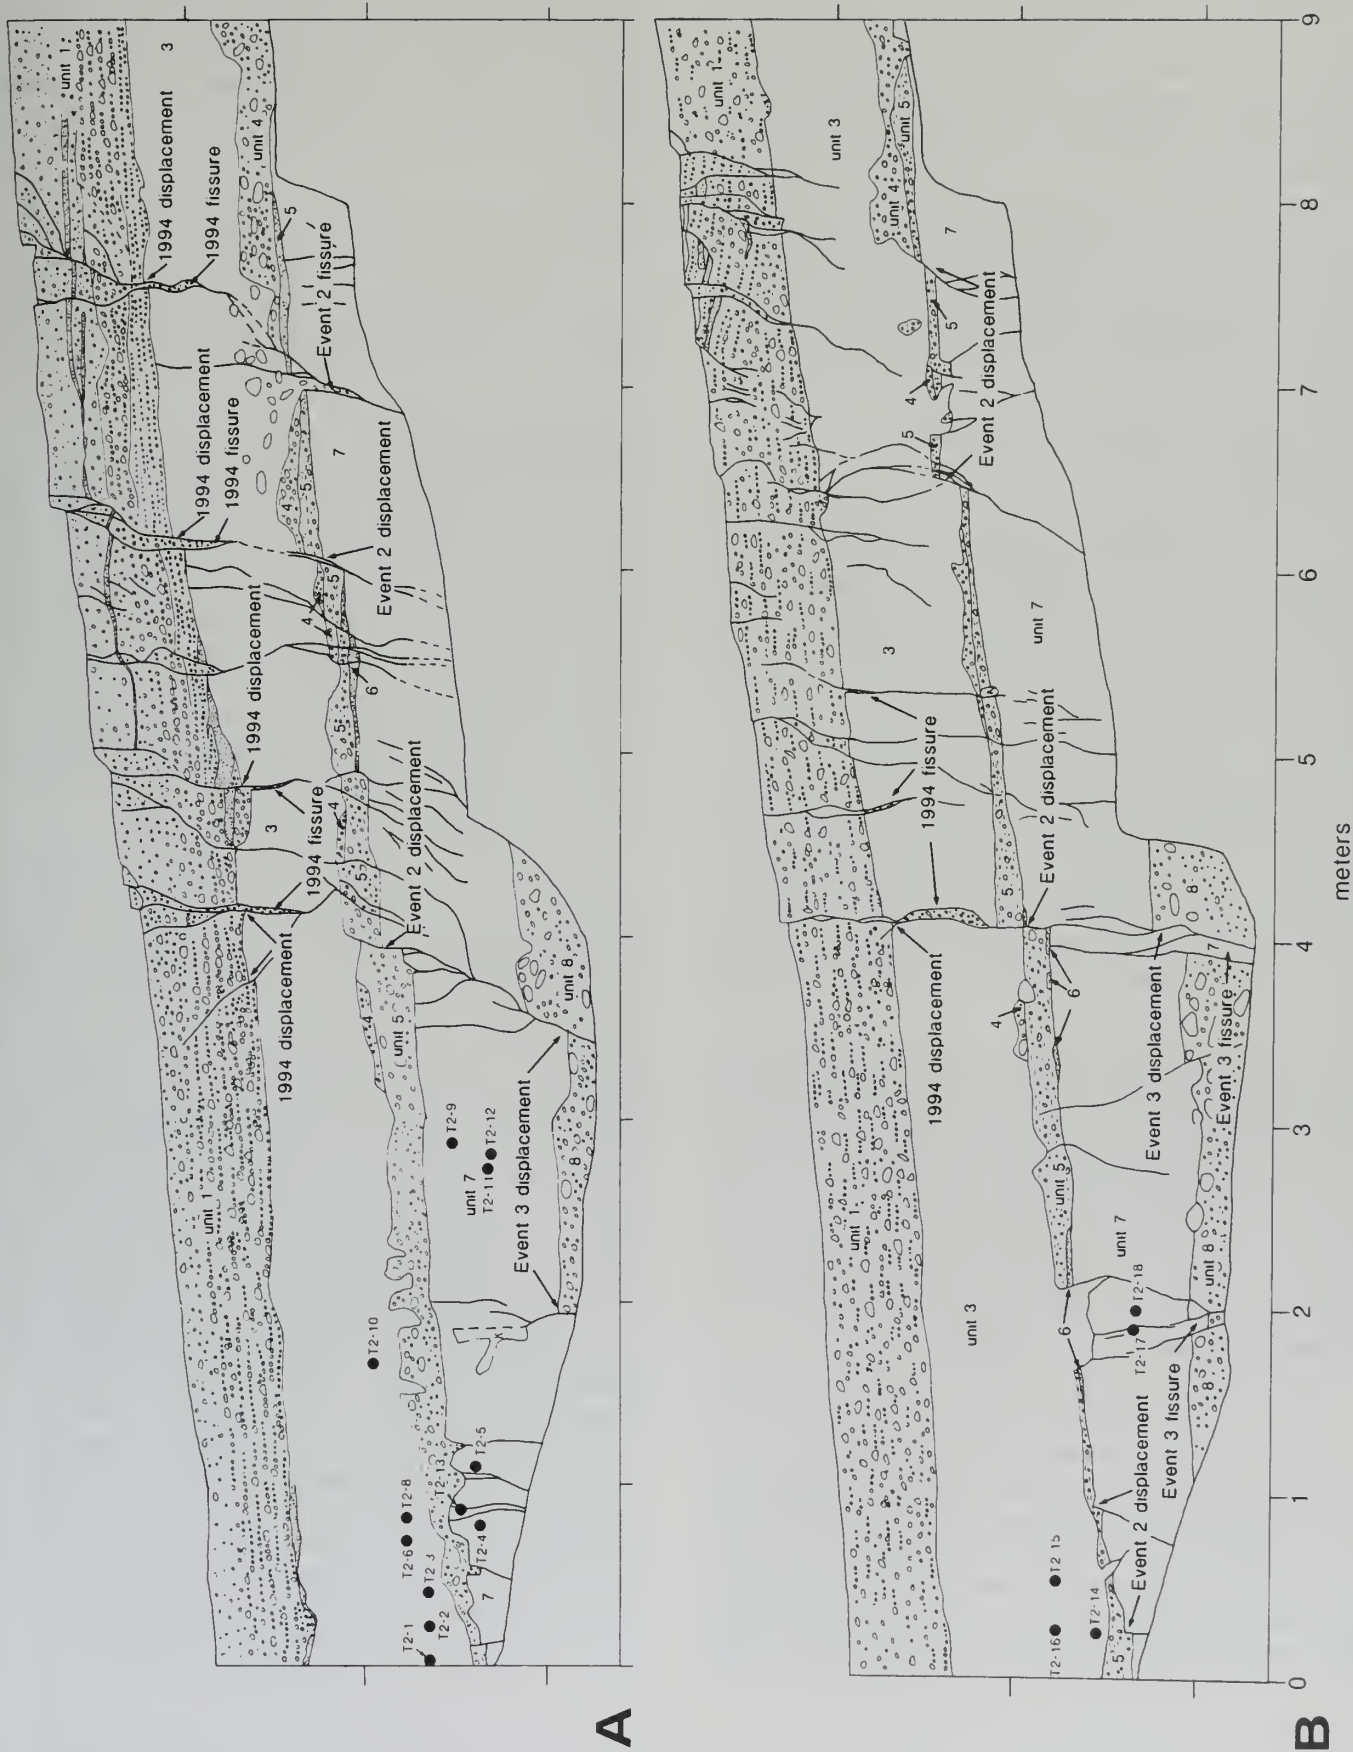
Figure 10. Log of Trench 2 in Holocene fluvial deposits on south side of Potrero Canyon (see Figures 4 and 6 for location). See Figure 7 for description of units. Large solid dot, ^{14}C sample locations; K = krotovina. See text for description of event horizons and event displacement. A, east wall; B, west wall.

The main structures exposed in the trenches are vertical to steeply (65° – 80°) north-dipping fractures. In Trenches 1 and 1A (Figures 8 and 9), these are distributed across a zone up to 4 m wide. Within this zone, most of the net down-to-the-north vertical separation of 26 cm due to the 1994 Northridge earthquake occurs along a single trace (Trench 1, meter 14; Trench 1A, meter 3). In Trench 2 (Figure 10), the total 1994 displacement is smaller, 12–16 cm, and displacement is distributed across a 4-m-wide zone. Infilled fissures are a common feature of the 1994 deformation. For example, a fissure up to 25 cm wide and extending to a depth of 1.6 m below the surface is present in the main displacement zone (Figure 8). It is filled with sandy gravel derived from upper unit 1. Several small infilled 1994 fissures are also observed in Trench 2 (Figures 10A and 10B).

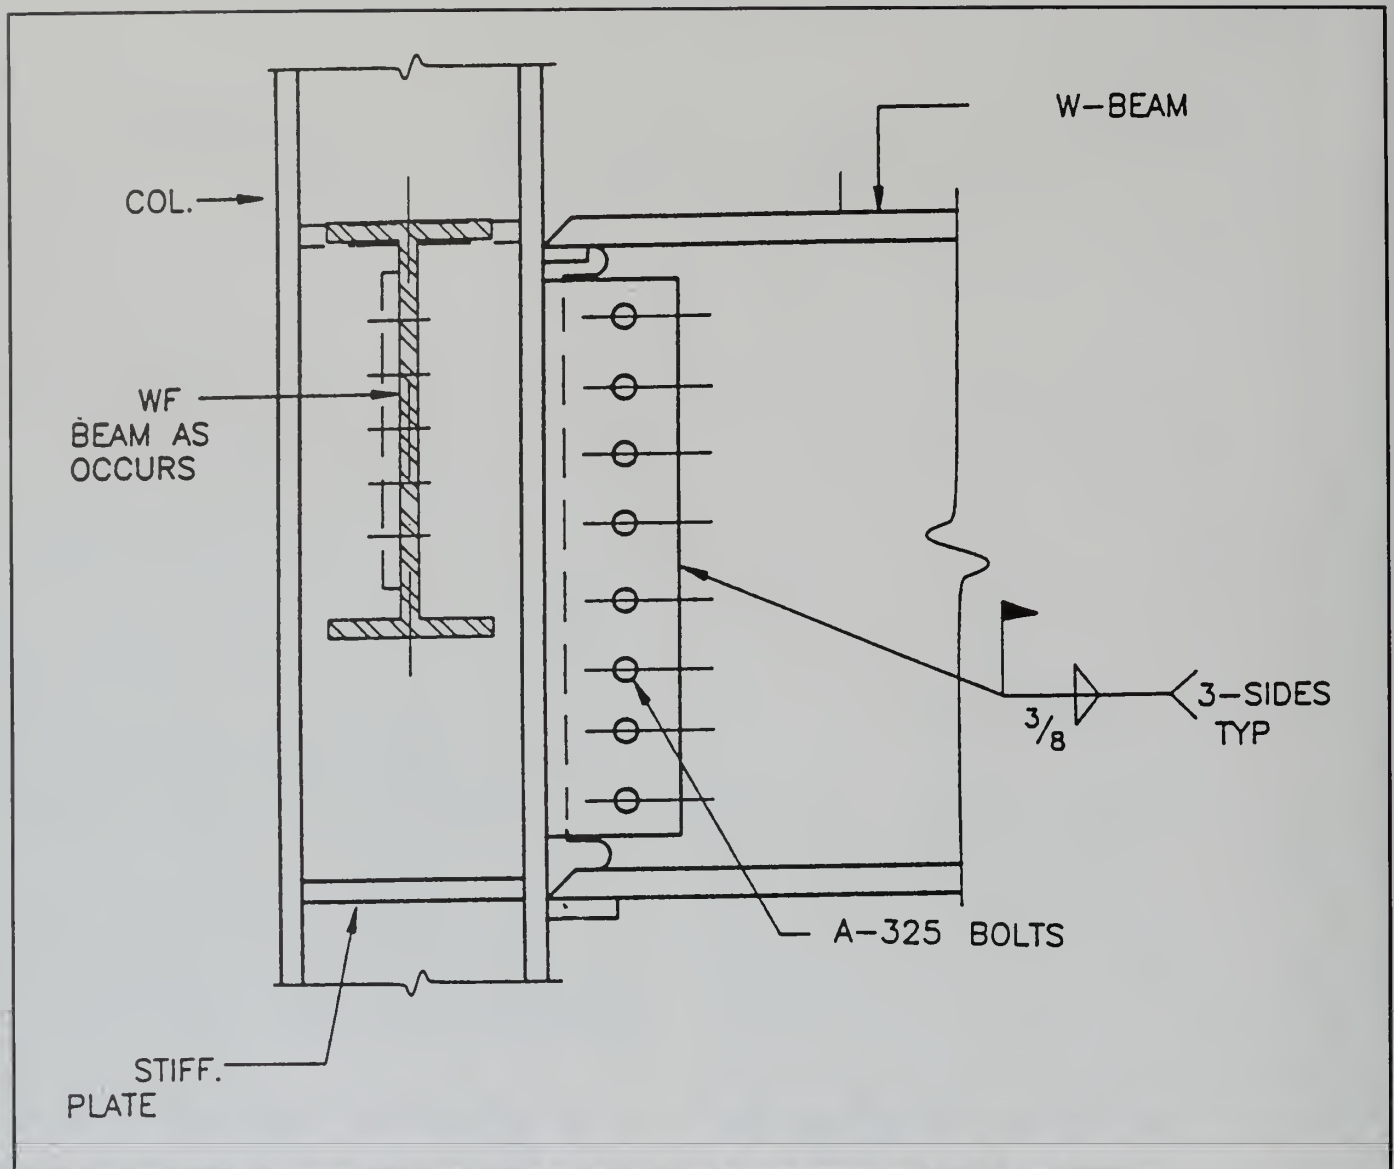
The typical beam-to-column SMRF connection that was extensively damaged is shown in Figure 1. This connection is prescribed in Section 2710(g)1B of the 1991 Uniform Building Code (UBC). The prescribed connection detail requires that the beam flanges be welded to the column flanges with complete joint penetration groove welds and that the beam web be connected to the column flange by welding or high strength slip-critical bolts. The welded flange/bolted web is the most widely used as discussed below.

Figure 1. The beam-to-column connection as prescribed in Section 2710(g) 1B of the 1991 Uniform Building Code

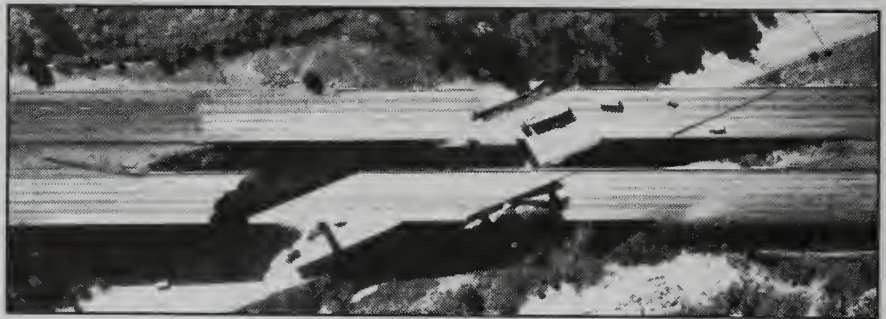
Photo 1. Damage to Gavin Canyon bridges due to the Northridge earthquake.

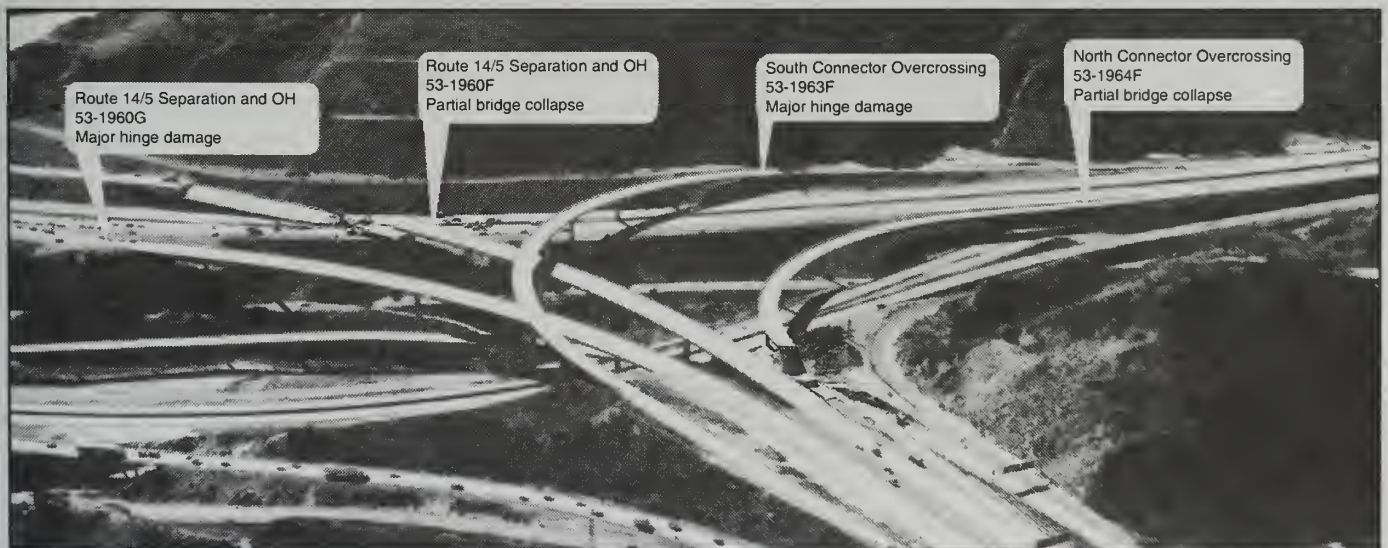
Photo 2. Bridge damage at Location 2 - Route 14/5 Interchange Overhead (53-1960F).

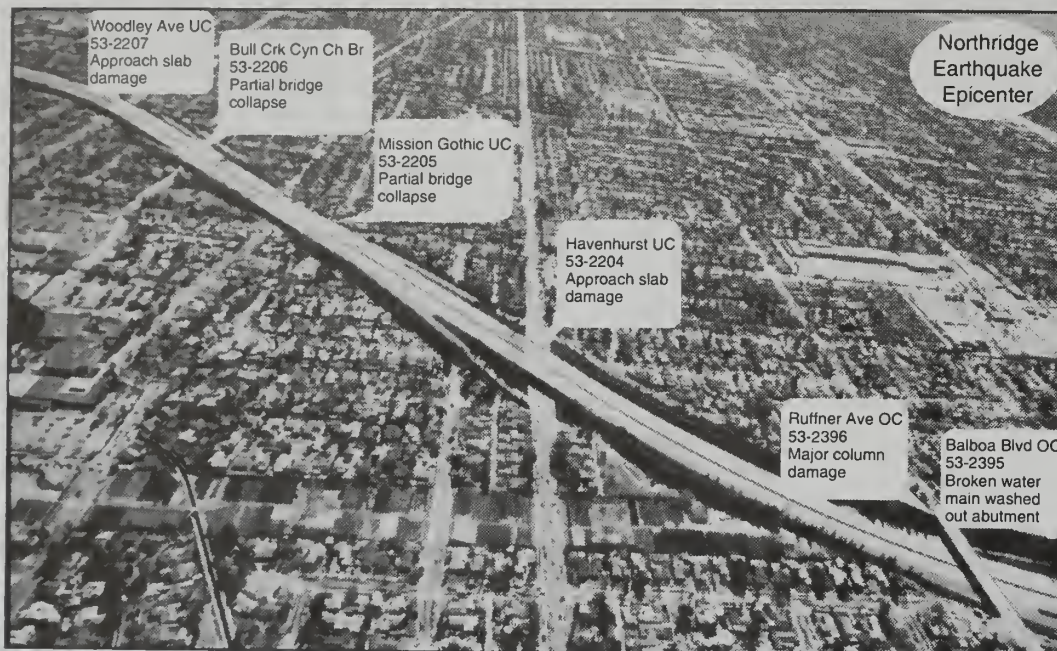
This is the closest site to the Northridge earthquake that experienced severe bridge damage (Figure 5, Photo 5). It is about 5 miles northeast of the epicenter of the earthquake. Every bridge along Route 118 for several miles west of I-405 suffered some damage from the earthquake. This damage ranged from approach settlements to superstructure collapse. Due to the extent of damage, a peak horizontal ground acceleration of at least 0.5 g is estimated for this site. This is somewhat higher than what was recorded on instruments near this site.

Photo 5. Bridge damage at Route 118 west of Route 405.

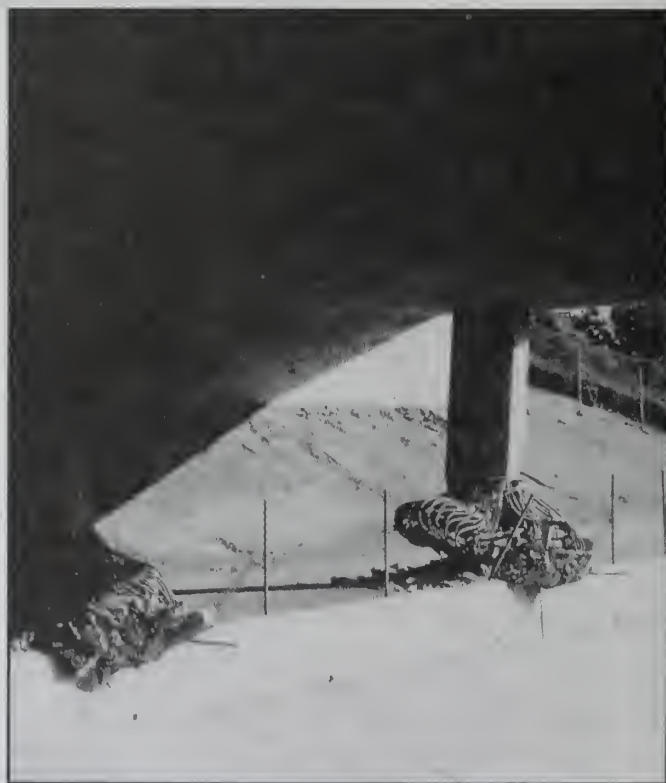
Major damage was caused by Bent #3 being monolithically cast with the channel wall. This made the columns much shorter and stiffer. The result was that the bent was too stiff to displace with the rest of the structure. It immediately failed causing secondary damage to Bent #2 of the right bridge and other minor damage. It should also be noted that no bridge in this area escaped damage during the Northridge earthquake.

Photo 7. Earthquake damage at Bent #3, Bull Creek Canyon Channel Bridge.

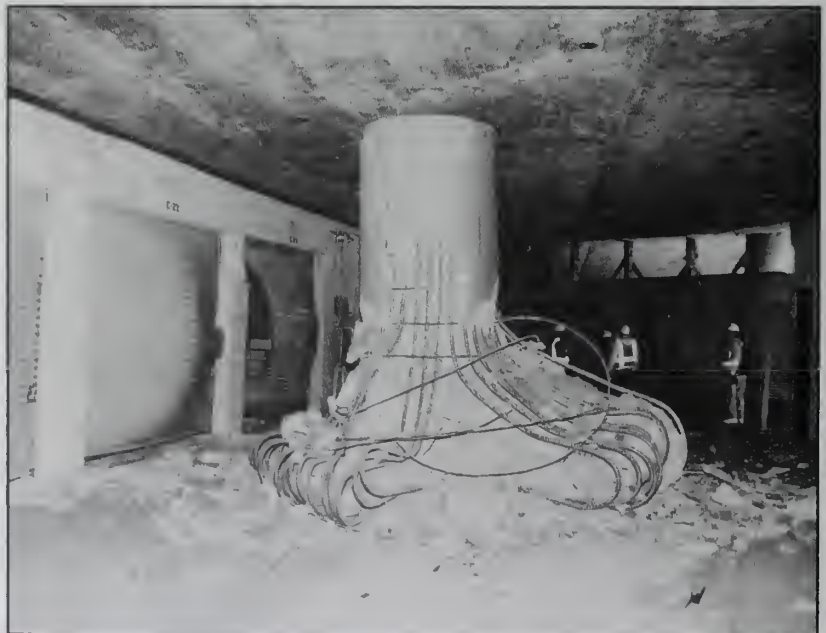
Photo 9. Damage to La Cienega-Venice Undercrossing

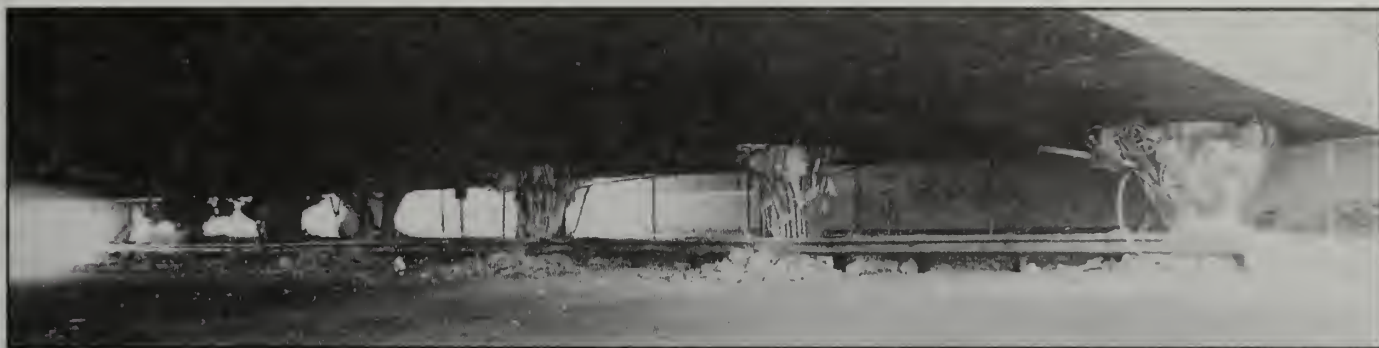
Photo 10. Damage to Fairfax-Washington Undercrossing.

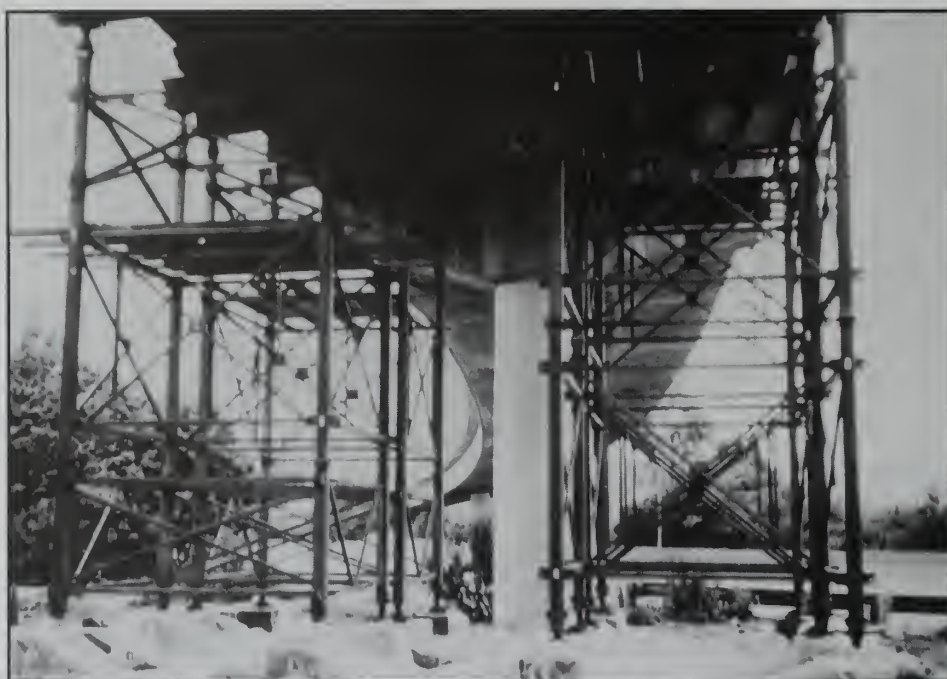
After the 1971 San Fernando earthquake, Caltrans began its first bridge seismic retrofit program. These retrofits were mostly to prevent the superstructure from falling off its supports. After the 1989 Loma Prieta earthquake, Caltrans began the second seismic retrofit program. These retrofits addressed a wider range of problems and were more sophisticated in their approach. Table 3 indicates what retrofit strategies are available and when they began being used. About halfway through this second retrofit program, the 17 January 1994 Northridge earthquake occurred. There were 132 bridges in the area of shaking that had a post San Fernando earthquake retrofit. Several of these bridges suffered major damage including Gavin Canyon Bridge and portions of the 14/5 Interchange. There were 63 bridges in this same area that had a post Loma Prieta retrofit. None of these bridges suffered significant damage. The most serious damage was on the Southeast Connector Overcrossing Bridge 53-1637F (Photo 11). This is a long, tall, prestressed con-

Photo 11. Damage to the Southeast Connector Overcrossing Bridge (53-1637F).

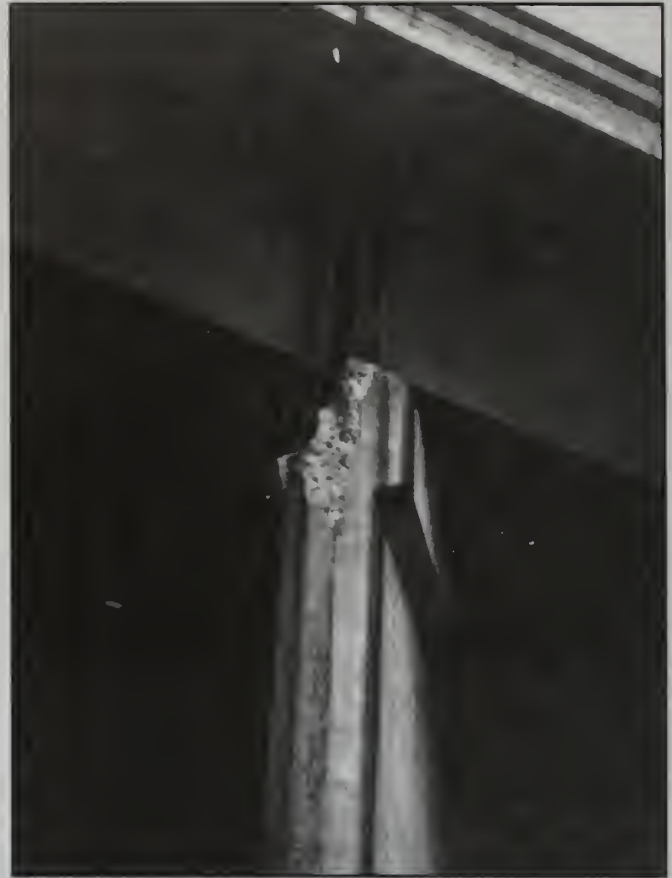
Photo 12. Santa Clara River Bridge

The Santa Clara River Bridge (53-0687L) is a highly skewed, 741 foot long, seven span structure. During the earthquake, many of the anchor bolts connecting the girders to the concrete piers pulled out (Photo 12). There was also banging and spalling of the abutments. The most interesting damage was cracking of the girders where they connected to the cross frames. The cross frames were staggered due to the bridge skew. These cracks were probably initiated through fatigue and propagated by the earthquake. It has long been known that staggered cross frames are a serious maintenance problem for steel bridges.

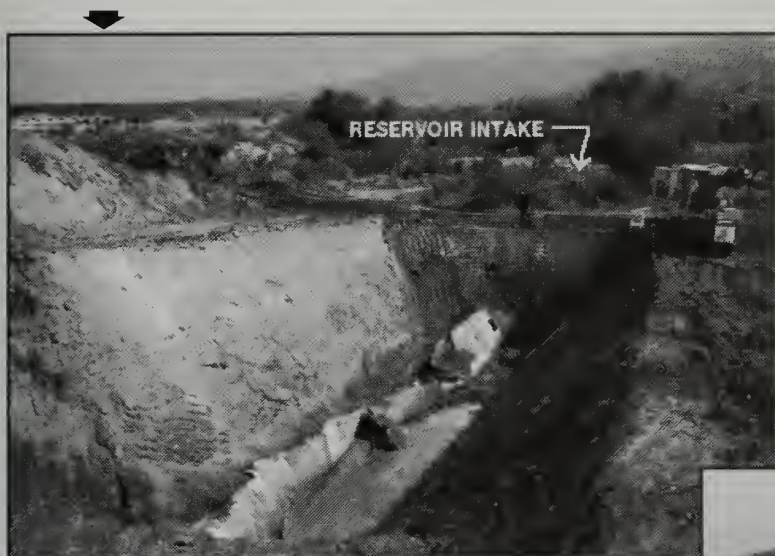
The reservoir is empty and serves as a flood control basin. Several two-inch-wide longitudinal cracks several hundred feet long were observed on the crest of the embankment. Some of the cracks could be probed up to 5 feet deep. Most cracking ran near the middle of the crest. Sand boils and a sink hole were observed upstream of the dam. The sink hole was trenched on 05/19/94 and the 96-inch diameter corrugated metal pipe low level outlet in the vicinity of the sink hole was found severely damaged (Photo 1). Surveys, dated April 15, 1994, of monuments and cracks were

received 04/25/94. Maximum crest movement was -0.66 ft vertical and -0.33 ft horizontal, upstream (u/s) at Station #10, 45 ft. south of axis line. Maximum width of crest cracks was 3.6 inches. Observations of cracks during trench exploration on 06/14/94 found main crest cracks to be 15 feet deep. Owner will be submitting crack repair plans to the Division for approval. Observation well readings transmitted on 05/5/94, indicate a maximum rise of about three feet at well 64-C. Site preparation and excavation for outlet repair work completed during September 1994. Repair application and plans to replace damaged outlet with a new 185-feet long 96-inch diameter concrete outlet conduit approved on 10/21/94. Outlet repairs currently underway.

Photo 1. Damaged low-level outlet, looking toward reservoir, Lower San Fernando Dam. Photos courtesy of Division of Safety of Dams.

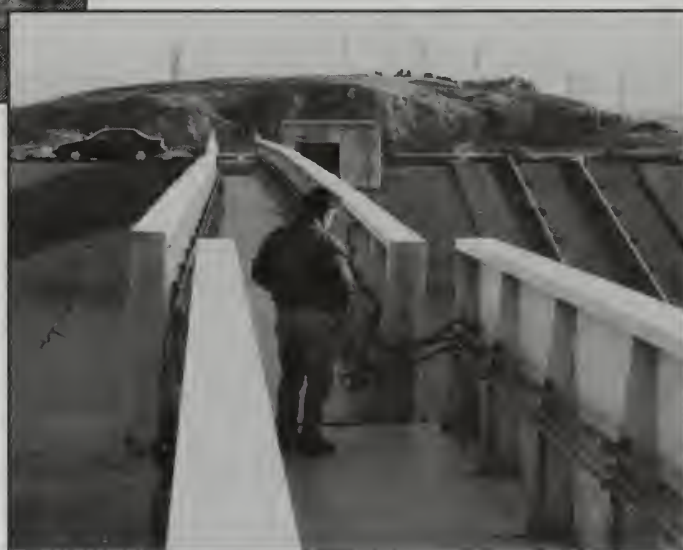
Hairline cracking was observed on the left end of the crest near the left abutment contact. Water surface level was at Elevation 1160, 15 feet below spillway crest at time of earthquake. Walkway to the outlet tower was separated about 2 inches over supports (north-south direction) and displaced about 16 inches horizontally (west-east direction), (Photo 2). Main dam settled 3.5 inches near the maximum section. Numerous cracks were discovered running longitudinally on the upstream slope asphalt concrete lining of the main dam, (Photo 3); more found when reservoir water surface lowered after earthquake. Transverse hairline crack 2 feet deep on left

Photo 2. Damaged walkway bridge to outlet tower, Los Angeles Reservoir Dam.

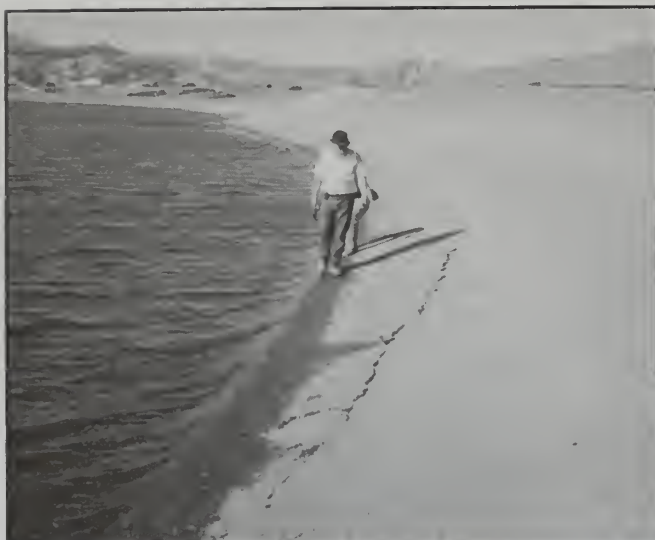
Photo 3. Longitudinal crack on upstream slope of asphalt concrete lining of the main dam, Los Angeles Reservoir Dam .

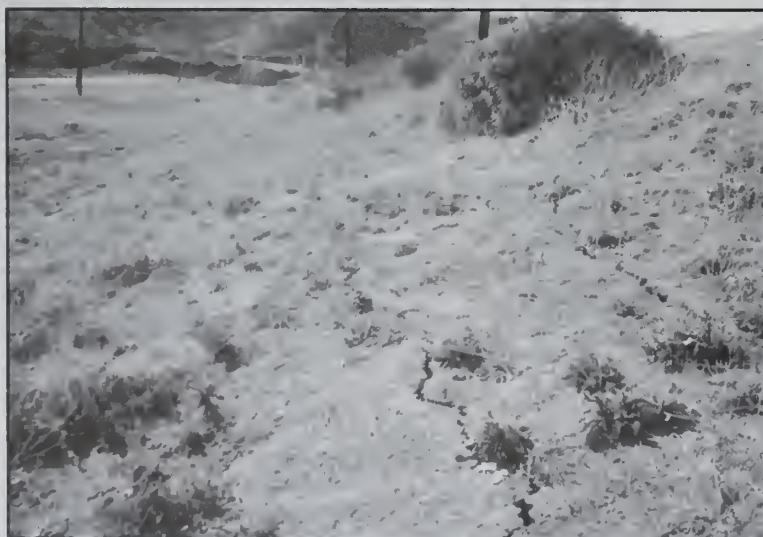
Photo 4. Several two-inch wide longitudinal cracks that were 40 to 60 feet long were found near the left abutment on the downstream slope, Upper San Fernando Dam.

The reservoir is empty and serves as a flood control basin. Transverse cracks found on the crest near the right abutment were up to 50 feet long and 3 inches wide. Several 2-inch wide maximum longitudinal cracks 40 to 60 feet long were found on the downstream slope and near left abutment (photo 4). Cracking was also observed at the spillway, and upstream slope of the dam. Monument and crack surveys dated April 15, 1994 were received 04/25/94. Maximum movement was -2.36 ft vertical at Station 8+00, 49.5 ft north of axis, and -0.6 ft horizontal, upstream, at Station 12+00, 49.5 ft north of axis. Observation well readings transmitted on 05/5/94 indicate a maximum rise of about 2 feet at well 68-B. Observation of cracks during trench exploration found main cracks on downstream slope near crest to be 5 feet deep. Owner plans to submit crack repair plans to Division for approval.

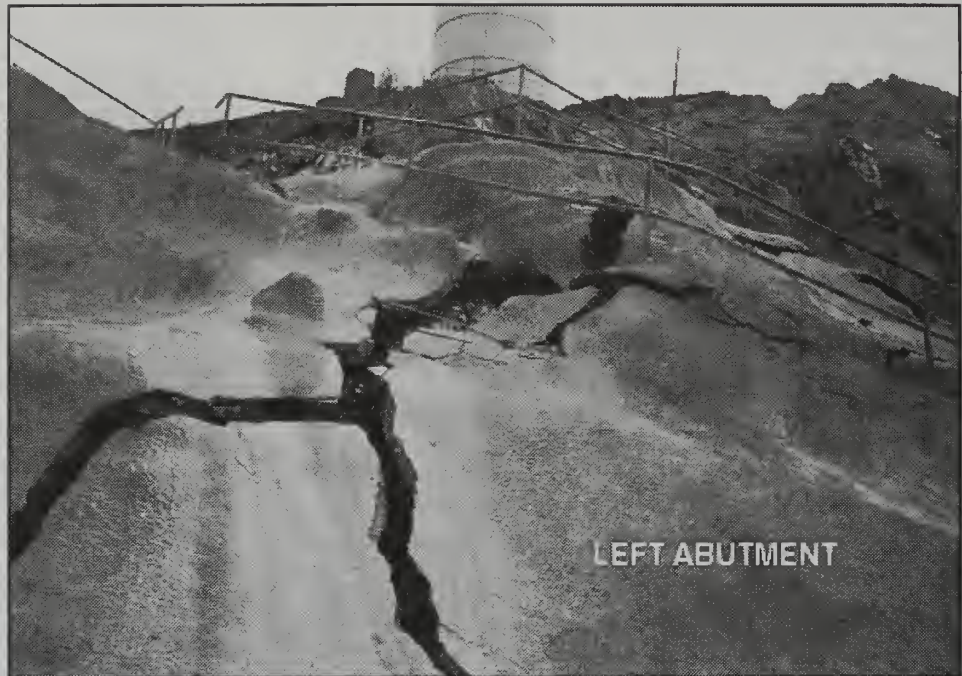
Photo 6. Gunite over the abutments was severely cracked, Pacoima Dam

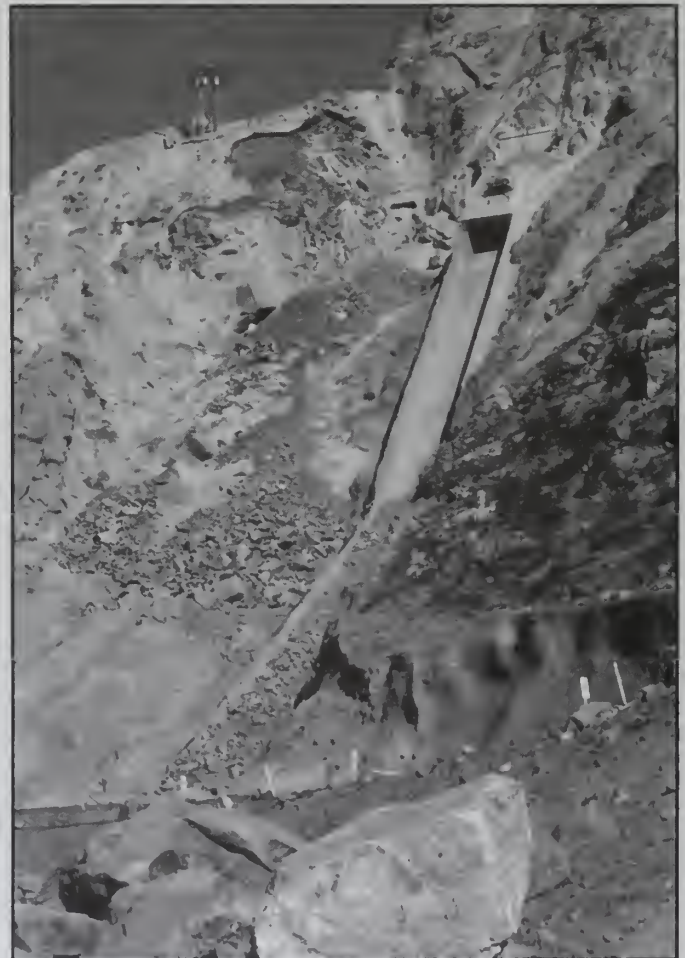
Photo 7. Earthquake damage to the spillway chute, Pacoima Dam.

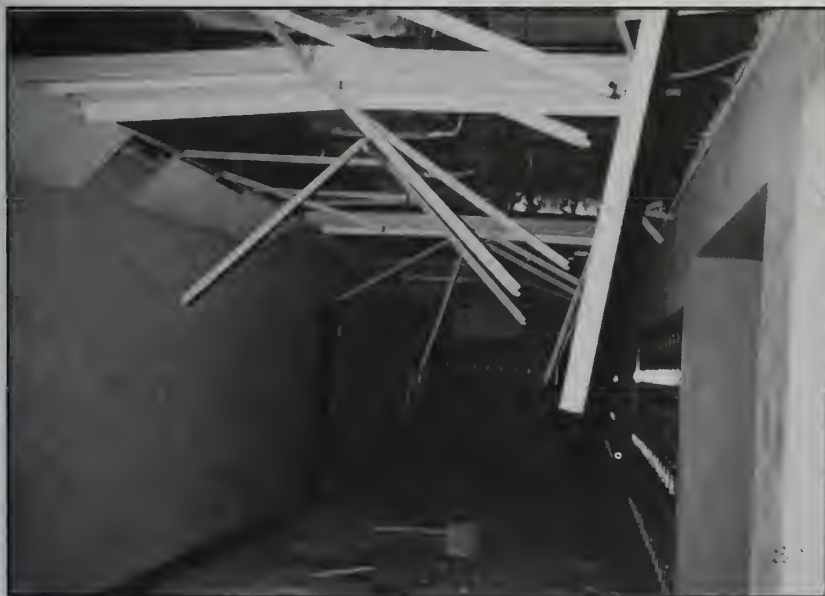
Photo 1. Acoustical ceiling failure at John F. Kennedy High School in Northridge, California. Photo by David Ring, Office of Regulation Services.

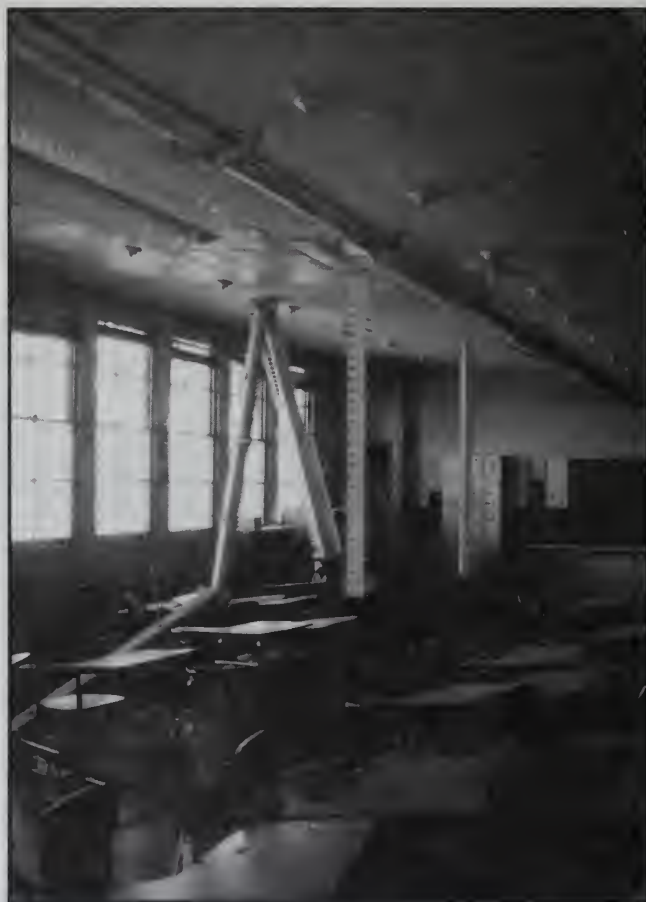
Suspended ceiling systems that were installed before the lessons learned from the 1971 San Fernando earthquake were the most common nonstructural element damaged. Typically these ceiling systems do not have lateral splay wires, compression struts, or adequate connections between members, all of which have been corrected in the regulations following the San Fernando earthquake. Young children can be severely traumatized even when only the lightweight ceiling panels fall because they perceive their school environment to be unsafe. This trauma can cause learning disabilities that may harm a child's future education compared to pupils who were not exposed to the trauma of falling ceiling tiles during an earthquake.

Photo 2. Pendant light fixture failure at Northridge Junior High School, Northridge, California. Photos by Gary McGavin, Seismic Safety Commission, except as noted.

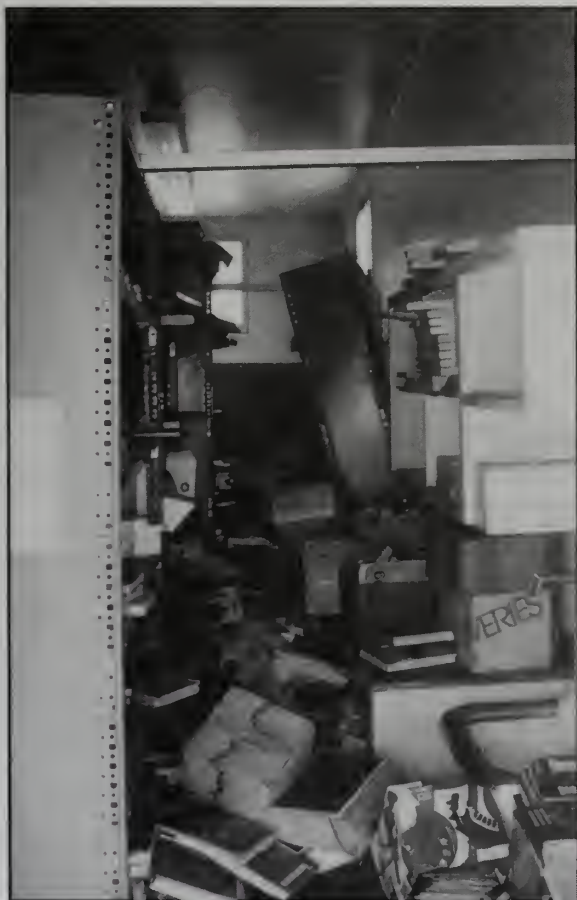
Photo 3 demonstrates the successful bracing of shelving in the foreground (left side of the photo) and the failure to anchor one side of the shelving in the background (right side of the photo). This is an example of the typical nuisance damage and cleanup for displaced contents of open shelving. If the earthquake had occurred 30 hours later, students and teachers would have been injured by these hazards that could have been mitigated at little or no cost.

Photo 3. Note conditions at braced shelf (left) compared to unbraced shelves (right).

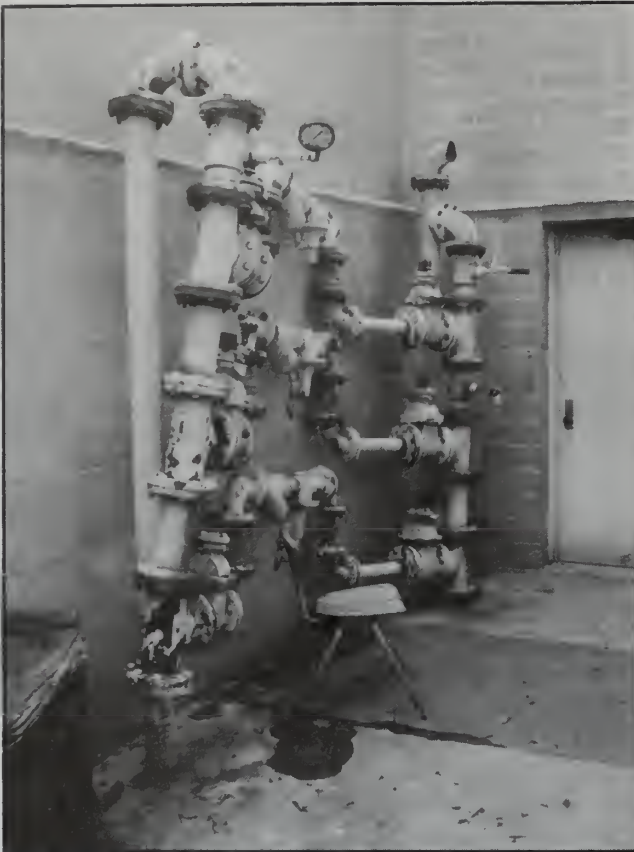
Photo 4. Earthquake damage to large utility piping in Kennedy High School.

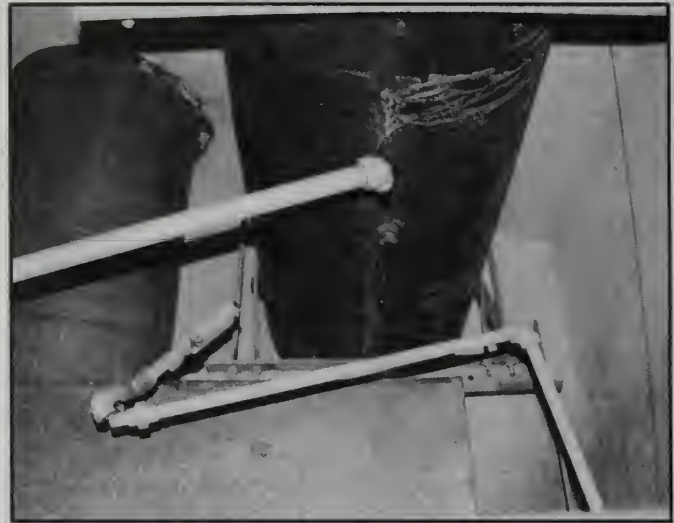
Photo 5. Earthquake damage to small utility piping at Danube Elementary School.

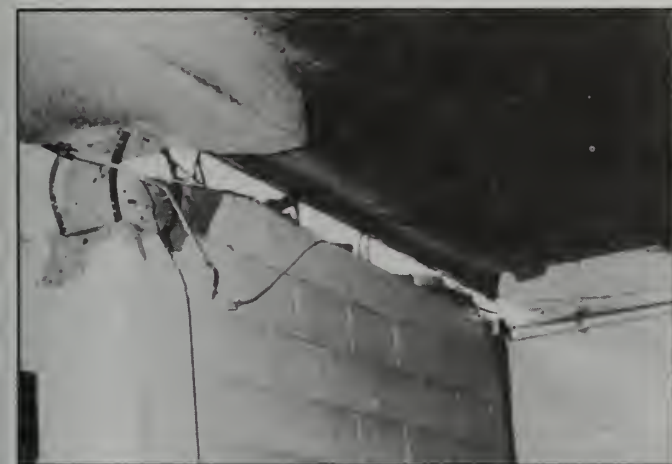
This is a 4-story poured in place reinforced concrete building with concrete shear walls. The columns and shear walls cracked at pour joints and along the diagonal direction of panels (Photo 1, a and b). Elevators, walls and partitions were damaged. The building remains unoccupied as of April 1, 1995.

Photo 1. (a) Bay Vista Health Care Center, a skilled nursing facility in Santa Monica, California. Failure occurred at the masonry wall-slab connection. ➡

(b) Bay Vista Health Care Center, showing cracking in south wall and in concrete beam.

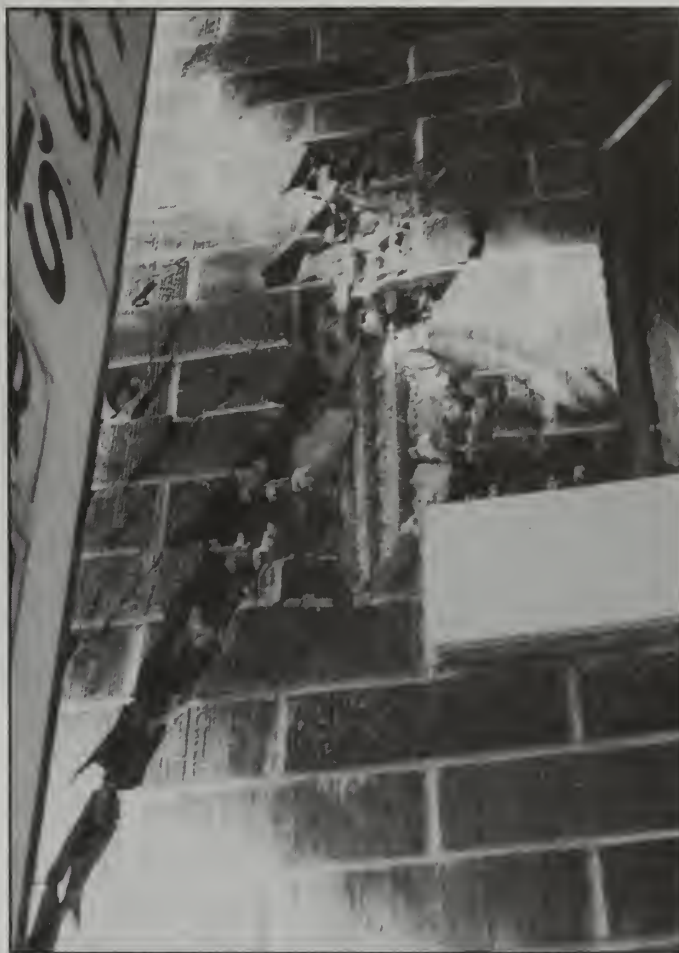
(2) Berkeley East Convalescent Hospital, Santa Monica

This is a four-story building constructed in 1972 to the City of Santa Monica building code. It sustained severe damage to the exterior reinforced brick masonry walls (Photo 2). The north wall at the first floor collapsed partially. The building remains unoccupied as of April 2, 1995.

Photo 2. Berkeley East Convalescent Hospital, showing shear failure of wall adjacent to a window.

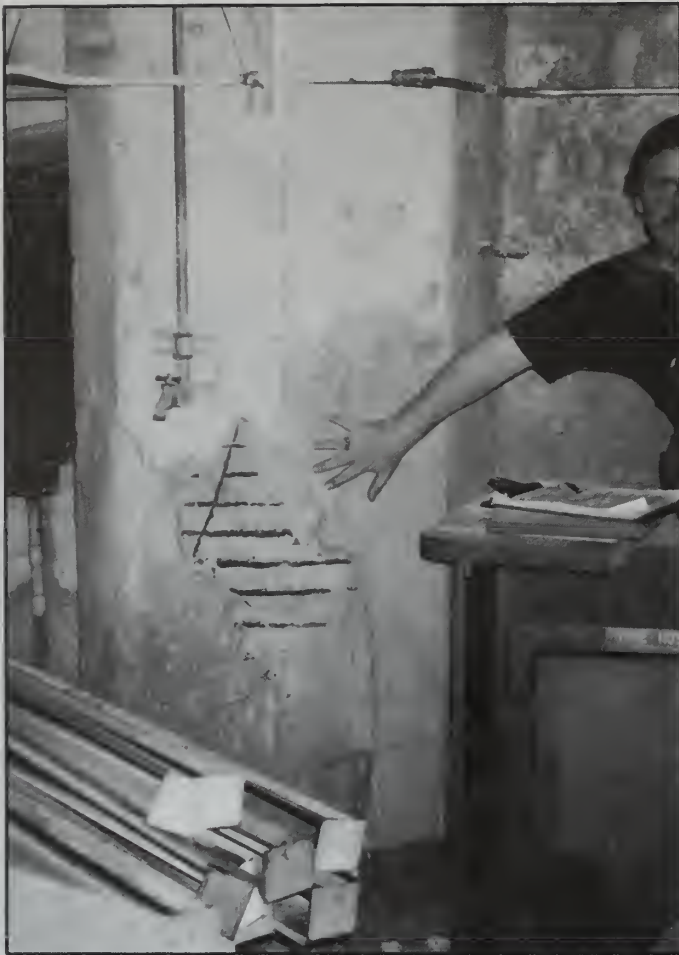
(3) California Medical Center, Los Angeles

Photo 3. California Medical Center, showing inadequate concrete cover on columns at basement level. The corroded spiral ties failed under earthquake loading.

This is a nine-story reinforced concrete building constructed in 1926. Six concrete columns were cracked (Photo 3). One column had cracks 1 inch to 2 inches wide. By February 8, 1994 the building was repaired and occupied.

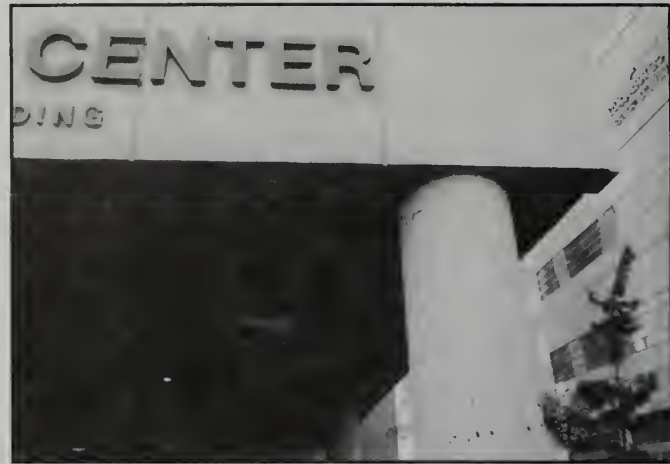
This eight-story concrete building with flat slab and shear walls had extensive hairline cracking of the shear walls. At least one exterior column had cracking at the second floor level (Photo 4). The building remains unoccupied as of April 1, 1995.

Photo 4. Cedars Sinai Medical Center, Schuman Building, showing cracking at the top of a column supporting the building. There was also shear wall cracking and broken windows in this building.

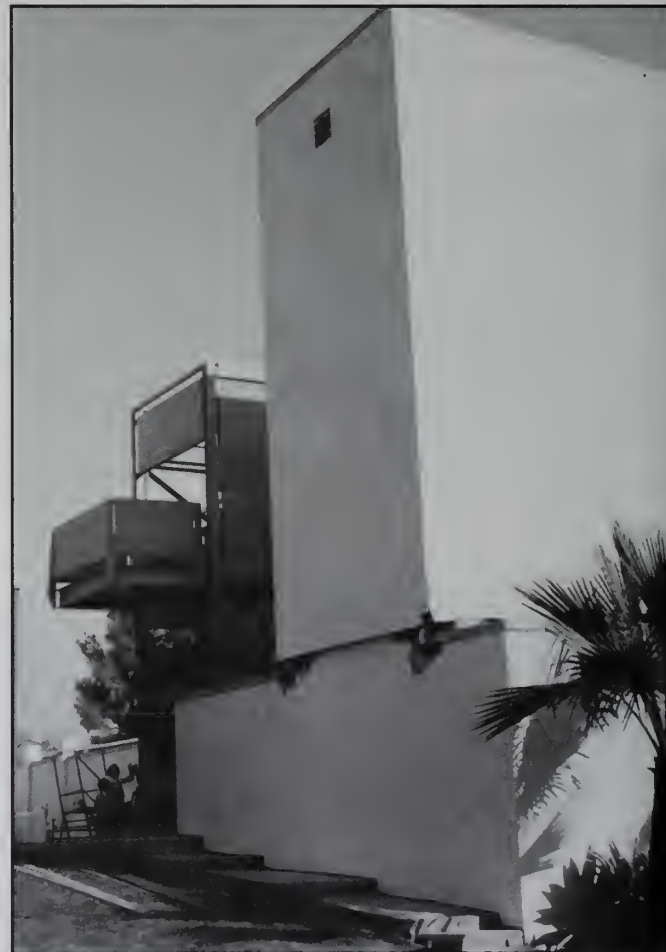
(5) Administration Building at Holy Cross Medical Center, Mission Hills

This three-story concrete building with steel beams in some locations was badly cracked at horizontal pour joints of concrete walls and at the support of steel beams (Photos 5a and 5b). This building was partially demolished voluntarily by the hospital authorities.

Photo 5a. Holy Cross Medical Center Administration Building showing failure at pour joints and connections.

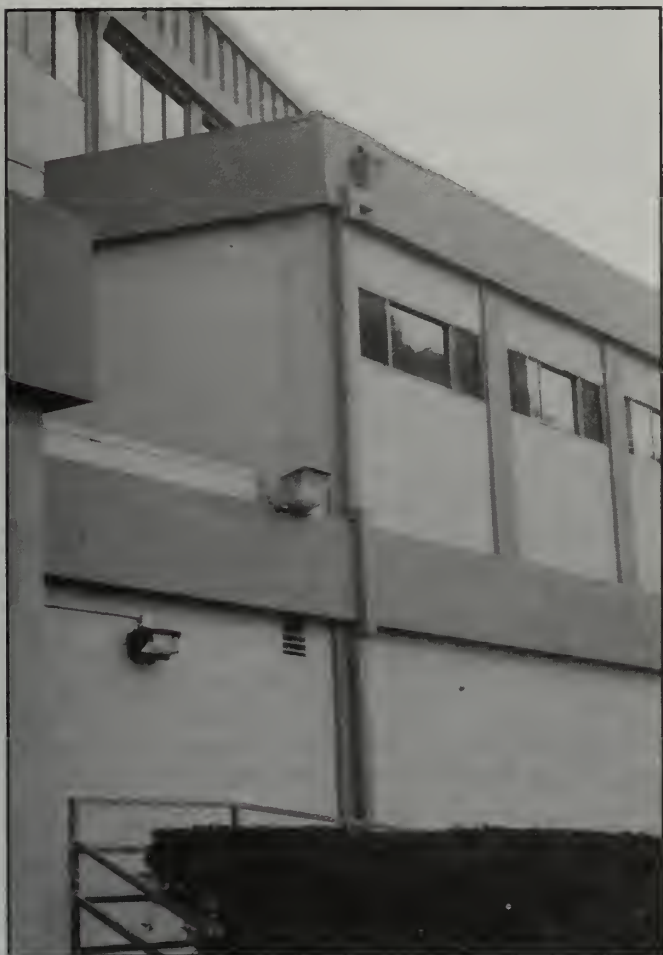
Photo 5b. Close up of failed connection shown in photo 5a. Holy Cross Medical Center.

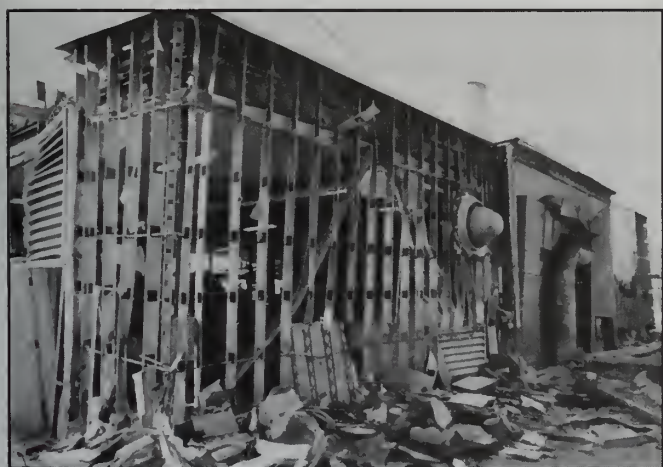
- (6) Kaiser Hospital, penthouse for rooftop housing of mechanical equipment, Panorama City

Photo 6. Kaiser Hospital, showing earthquake damage to penthouse structure on roof of hospital and damage to equipment inside the storage structure (north wall of building).

This braced steel frame structure atop the existing pre-Act hospital building sustained severe damage to the structure and the equipment (Photo 6). The hospital building, though not tagged red, had severe water damage and broken glazing in the top four stories requiring temporary evacuation of the patients. Earthquake repairs have been completed.

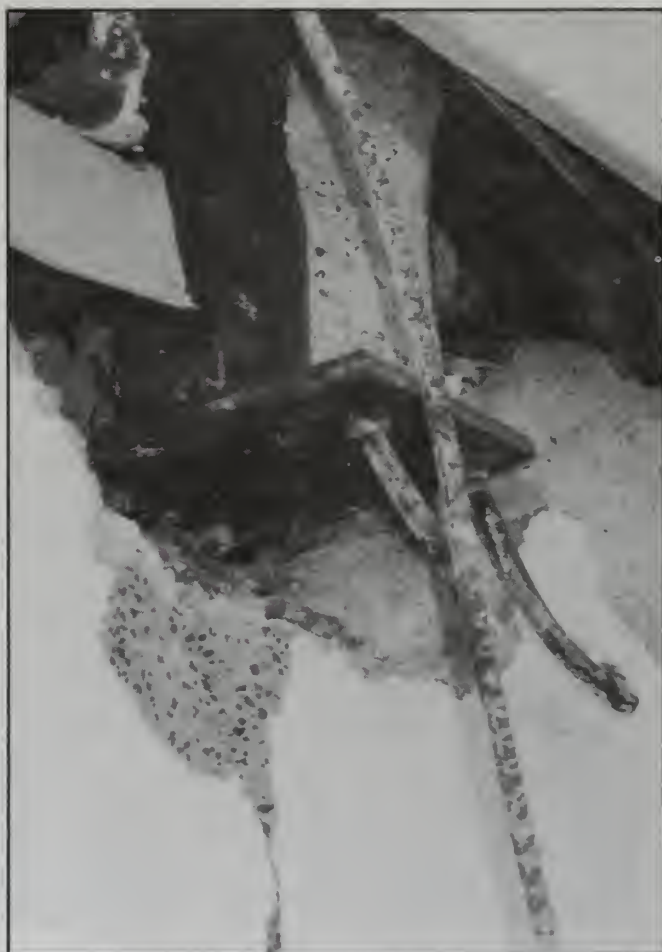
- (7) Psychiatric Hospital at Los Angeles County/USC Medical Center, Los Angeles

This nine-story concrete frame masonry shear wall building had severe structural and non-structural damage (Photo 7). Columns developed extensive "X" cracking at spandrels. Damage to elevators, mechanical and electrical equipment, water piping and interior walls and ceilings was reported. Building was evacuated and remains unoccupied as of November 1, 1994.

Photo 7. Psychiatric Hospital at Los Angeles County/USC Medical Center, showing cracking and separation of two perpendicular walls at the corner of the building on the second floor.

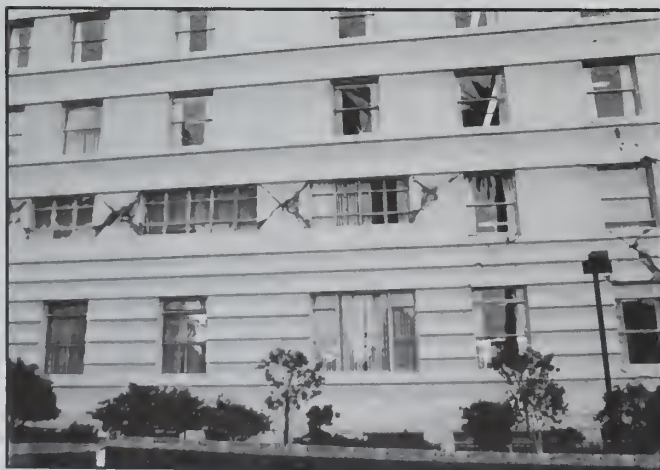
Photo 8. St. John's Hospital and Health Center, showing failure of shear wall on second story level of the North Wing and cracking and shattering around windows. The North Wing building was demolished.

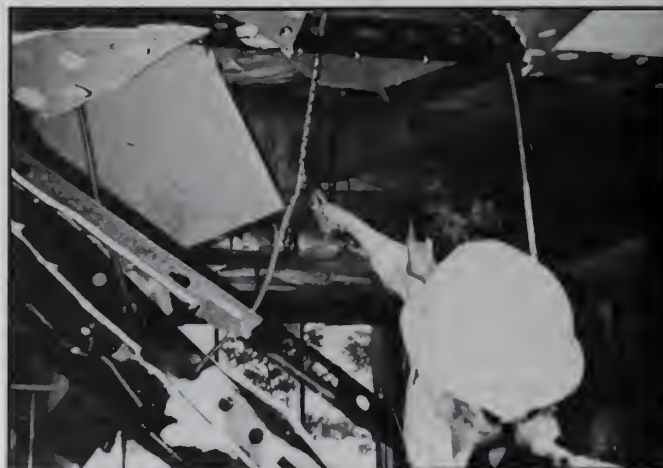
Photo 9. Cedars Sinai Medical Center, Los Angeles, showing collapsed ceiling in lobby.

Thalian Building. Damage included localized collapse of ceiling and damage to equipment and water piping. Ceiling collapsed because it could not sustain the relative motion of the two primary structures at seismic separation joint (Photo 9).
